# JFK Causeway

Wiss, Janney, Elstner Associates, Inc.

Brian D. Merrill, PE

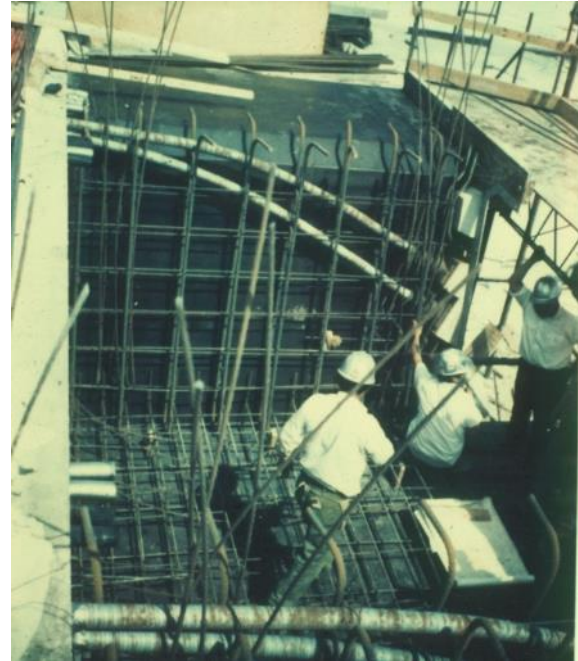
## Duct Alignment

- Used thin-walled metal ducts
- Insufficient attachment to rebar
- No inflatable alignment tubes
  - High friction values
  - Replace several tendons due to installation trouble
  - Tendon blockage/duct pullout

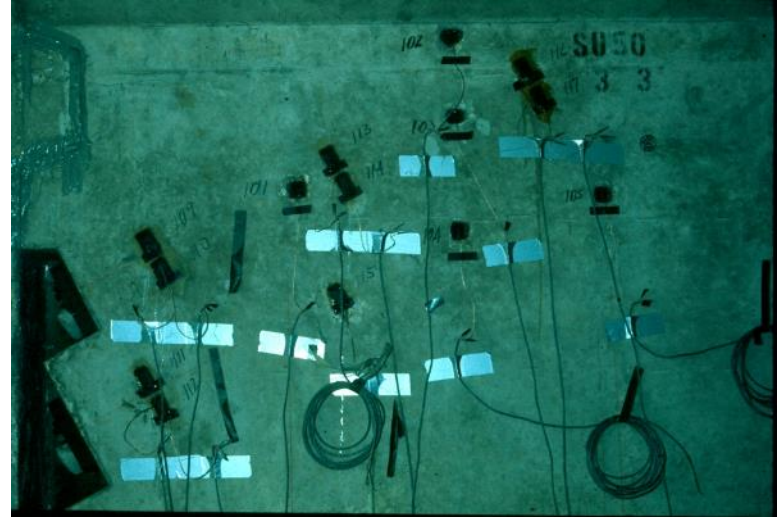
- Web cracking at cantilever tendons
- All 88 segments cast when discovered
- Project shut down 9 months for study

Cracking caused by:

- Anchorage geometry changes
- Insufficient local zone reinf.
- Other rebar cut for tendons
- **Did not affect capacity – epoxy seal**

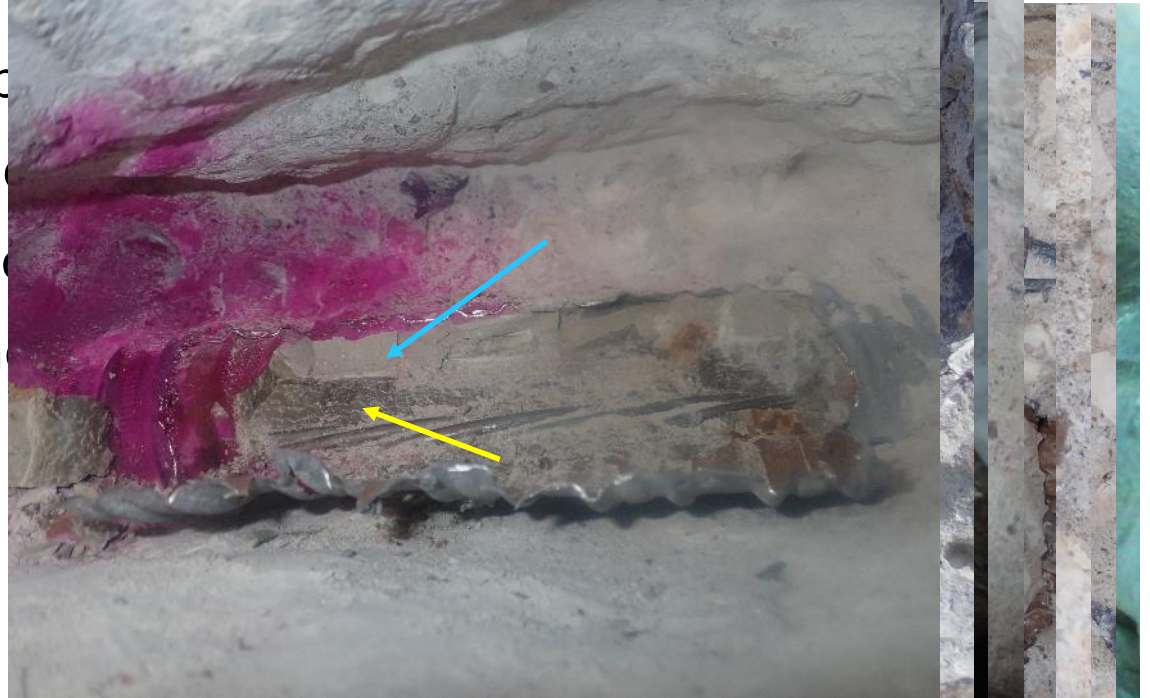
# Assessment Findings – PT System

- Only one anomaly type
- Two grout voids found
- Strands were in like no
- Evidence of regrouting
- Pictures...

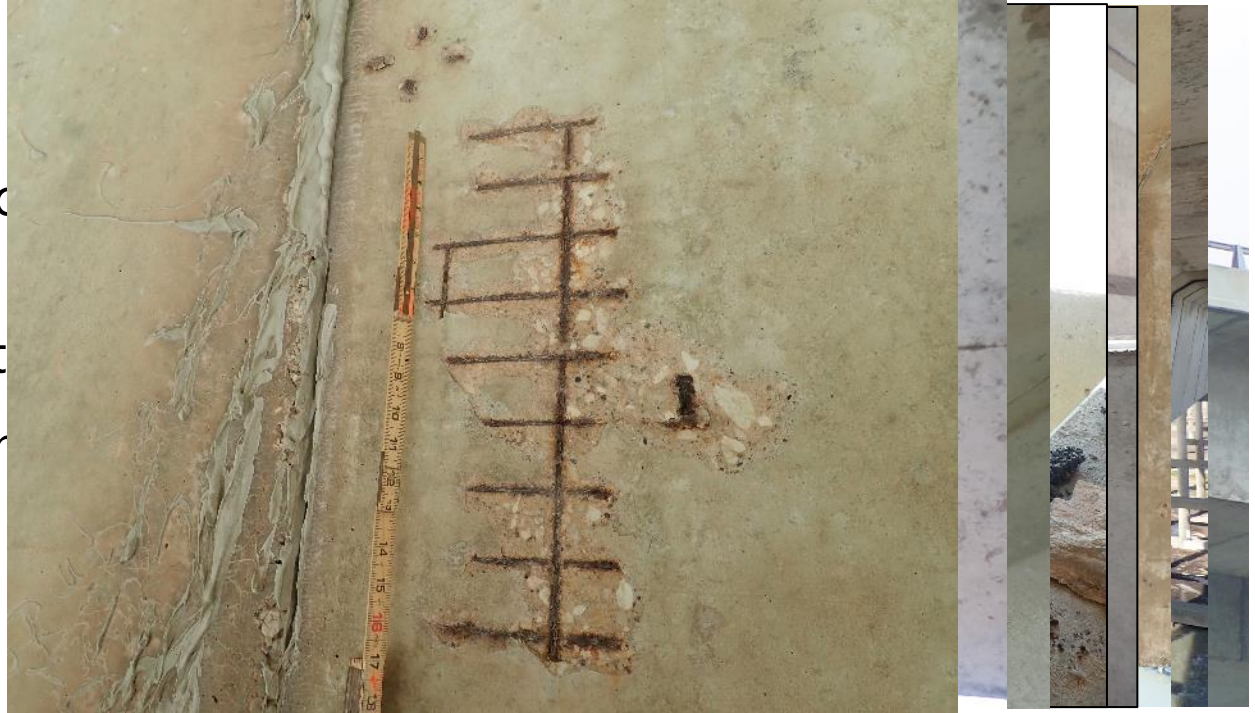
## Exterior:

- Cracking in web (epoxy seals intact, cracks)
- Spalling of end top
- Corrosion/spalling
  - Pictures...

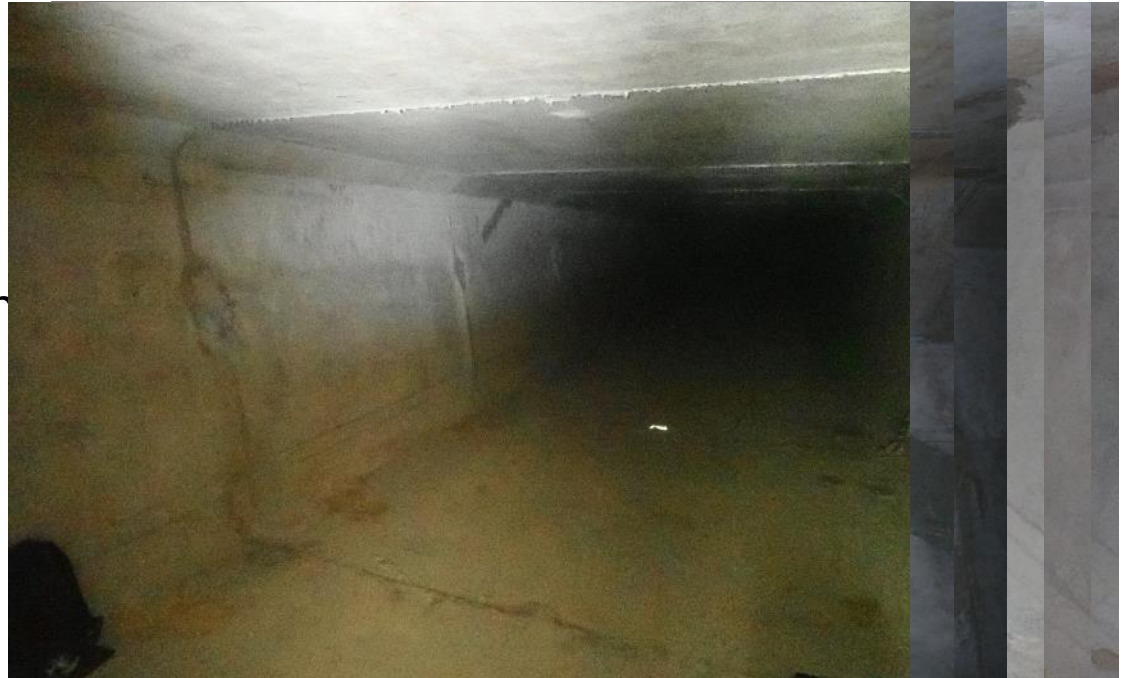
## Interior

- Diaphragm cracking
- Web cracking
- Moisture at deck anchor
- **No Joint Leakage**

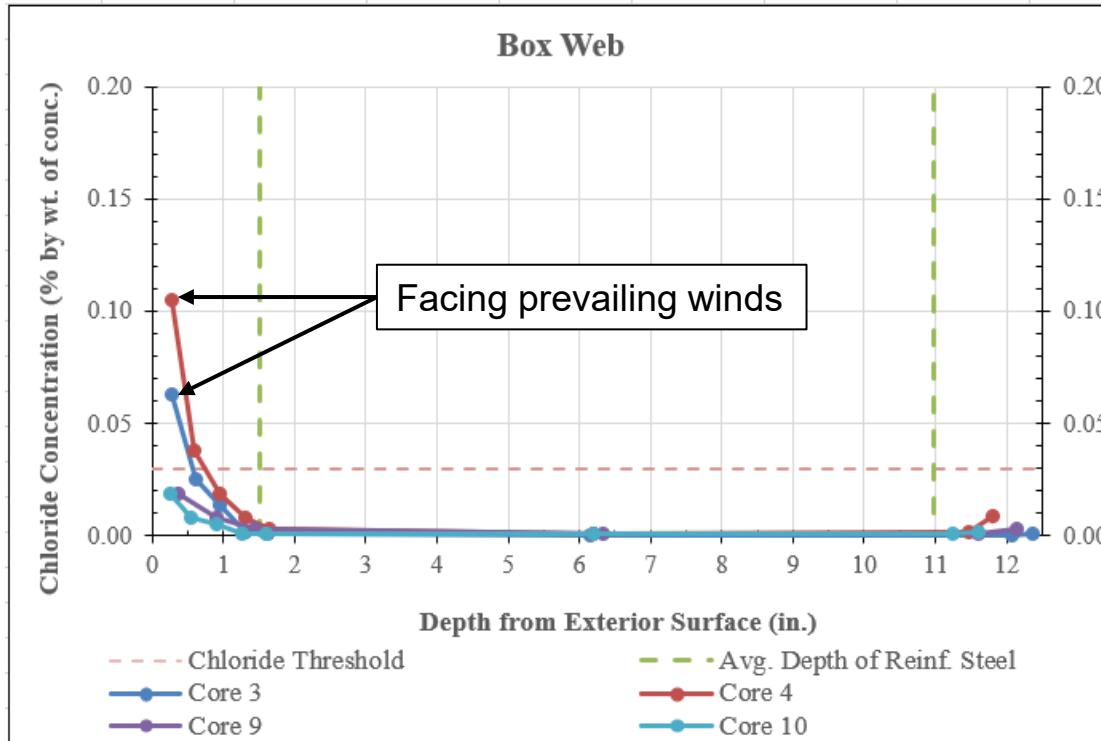
# Chloride profiles - Webs

Exterior Face

Facing prevailing winds

Interior Face

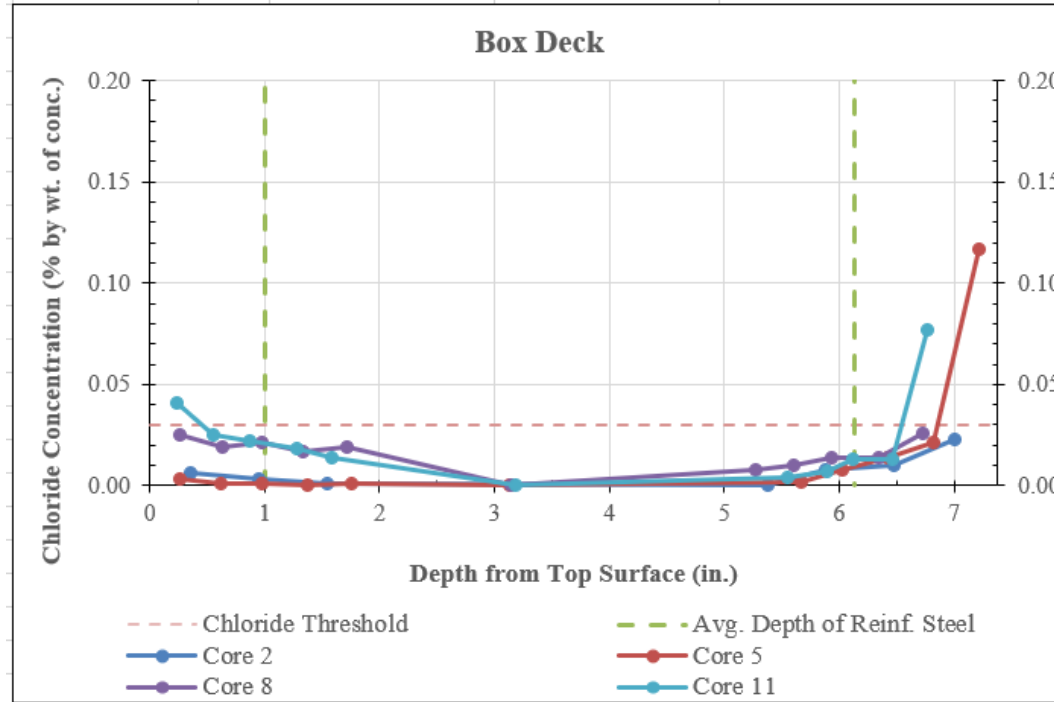
# Chloride profiles – Top slab

Top - Under Asphalt

Wing Underside
