Concrete Segmental Bridges  
**Retrofit Ends Michigan Moratorium**

### **Bridges Lifted Up**

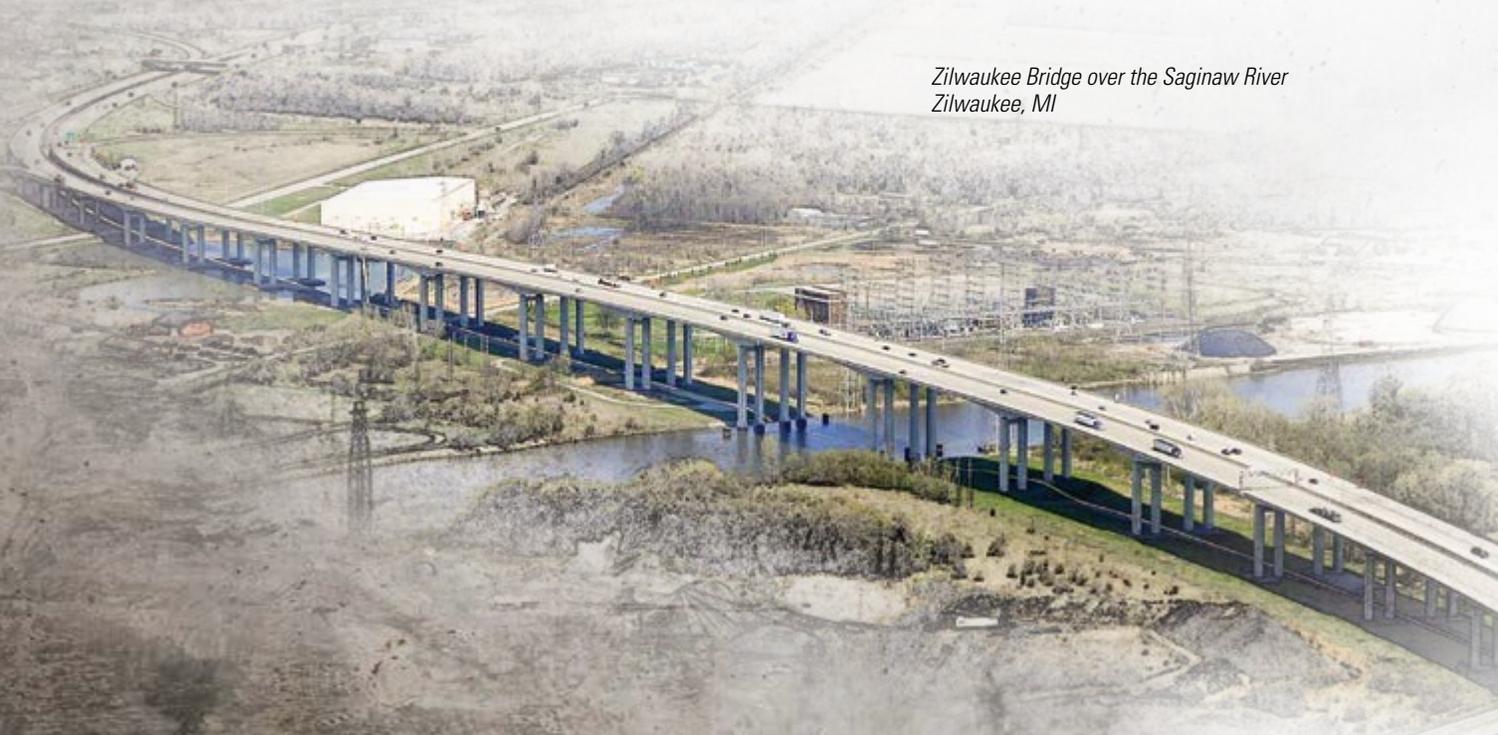
*Zilwaukee Bridge over the Saginaw River*  
*Zilwaukee, MI*

The moratorium stemmed from work on the Zilwaukee Bridge over the Saginaw River in Zilwaukee, Michigan. The largest single-cell segmental box-girder design bridge in the U.S. at the time, it features twin 8,100-foot bridges with segments varying in depth between 8 feet at midspan and 20 feet at the piers. A major accident occurred during the construction, and although the damage was repaired and the bridge now has been in service for 26 years, the experience left the previous generation of MDOT leadership leery of considering segmental construction.

In addition, segment design details and complex erection sequences due to the bridge’s size created long-term challenges, Chynoweth explains. Problems arose due to the amount of creep and shrinkage in the bridges. Shortly after completion in 1988, pot bearings began leaking elastomer and polytetrafluoroethylene (PTFE) discs ground against the steel pot sealing. “We found that in the first 12 years, there was a lot of creep and shrinkage as the post-tensioning relaxed and the original bearings became over-rotated and over-translated,” Chynoweth says. “Crews had to keep trimming the plates to allow the bridge to rotate.”

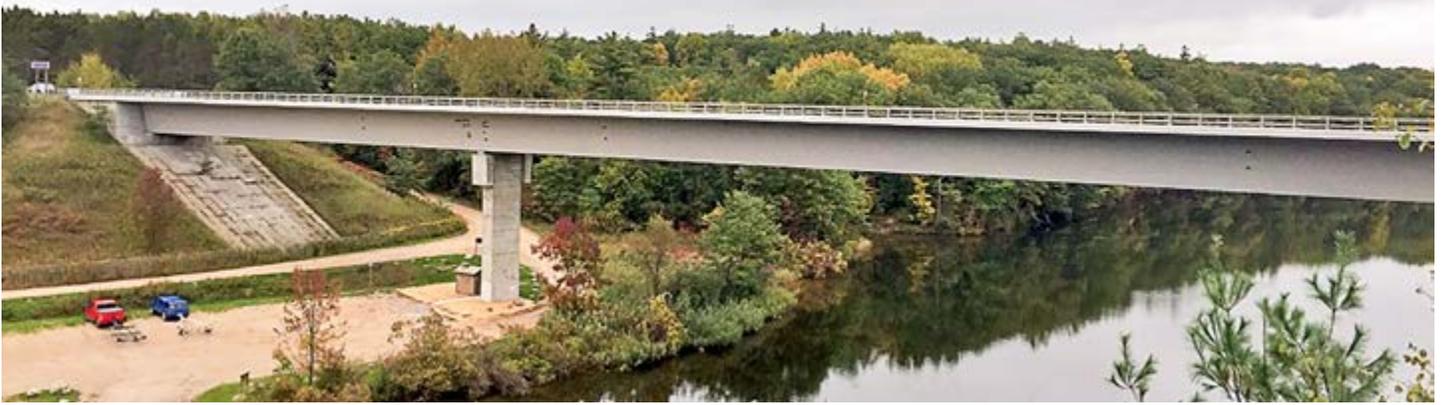
*Muskegon River Bridge over US-131, MI*

The same process was also used in the fall of 2015 on the Muskegon River Bridge over US-131, another concrete segmental bridge completed in the same time period as the Zilwaukee Bridge. Engineers again drilled holes in the bridge to locate reinforcement, then post-tensioned concrete retrofits to support longitudinal harped external post-tensioning

cables. Deviator diaphragms were cast at end spans, and piers diaphragms were modified to adjust for the work, Rogers explains. Concrete corbels were poured on either side of the piers so post-tensioning could be provided across them to redistribute the load with grout-filled flat jacks.

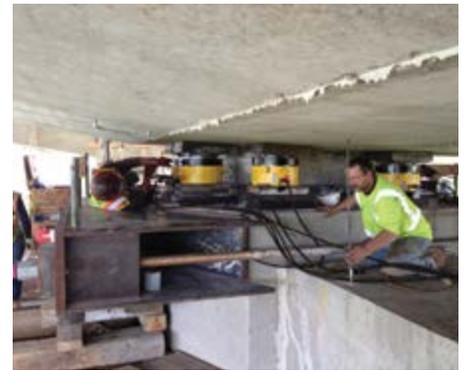
*Installation and stressing of pier compression collars prior to jacking.*

To replace the bearings on the two bridges, the superstructure was lifted with hydraulic jacks. Engineers externally post-tensioned the bottom slab at the piers with 2.5 million pounds of force to alter accommodate the change in load path from the bearings to the jacks on the slab floor. Jacks were placed as close to each pier as possible. Eight-800-ton jacks on each side of the pier segment were used to lift at each point, allowing them to lift 10 to 15 million pounds. Once the superstructure was lifted, the bearings were sawed out, rebar reinforcement was placed, bearings were replaced, the joints were pressure-grouted and cured for three days to achieve 5,000 psi compressive strength, and the bridge was lowered.

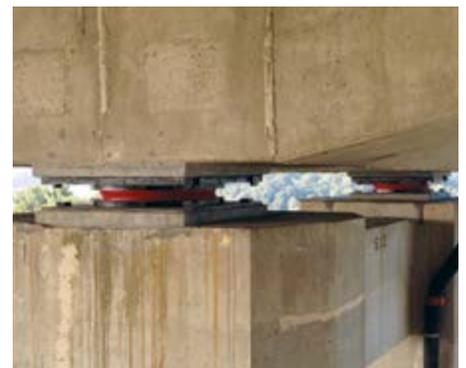
*Completed disc bearing.*

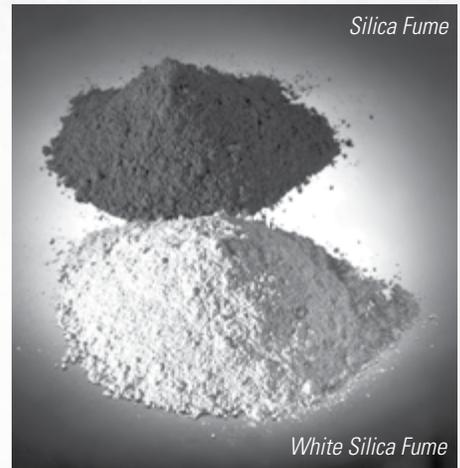
*Silica Fume*

*White Silica Fume*

MDOT also has taken steps to improve the overall durability of its concrete bridges, creating a Grade DM mix of high-performance concrete that includes slag cement and silica fume. “We’re using it for bridge decks now,” says Rogers. “It’s less permeable than other mixes and gains strength quickly.” It can achieve a seven-day strength of 6,500 psi.

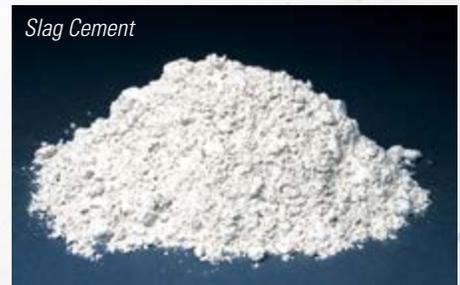
*Slag Cement*
