# TechBrief

U.S. Department of Transportation  
Federal Highway Administration  
Office of Bridges and Structures  
FHWA-HIF- 20-041  
February 2022

# Methodology for Risk Assessment of Post-Tensioning Tendons

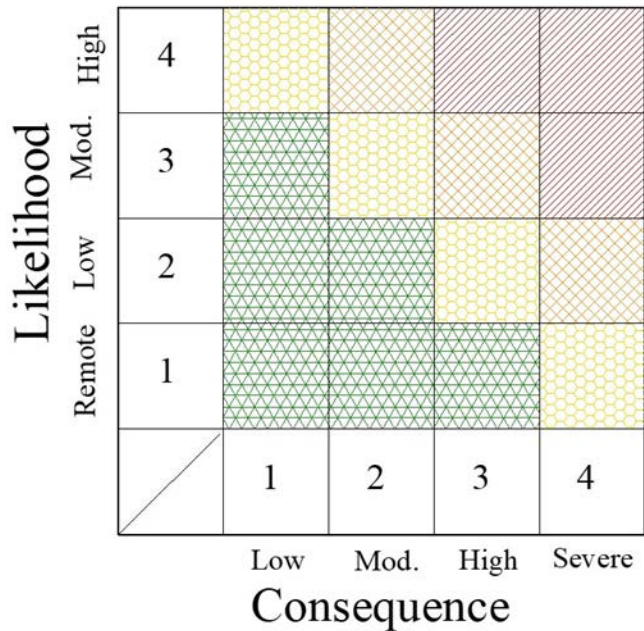
The OF and CF ratios can be used to locate the analyzed tendon on a risk matrix such as shown in Figure 1 by categorizing the likelihood (OF) and the consequence (CF). For the OF, categories of remote, low, moderate or high are used to characterize the likelihood, while categories of low, moderate, high, and severe are used to characterize the consequence for the CF. The factor for appropriate categories is determined by multiplying Equation 2 by 4, resulting in values on a scale from 0 to 4. For the OF, values between 0 and 1 are identified as “Remote,” meaning the likelihood of damage is estimated to be remote, given the attributes and criteria. Values 1 or greater but less than 2 are ranked as “Low,” and so on. The CFs are categorized in a similar manner based on the CF attributes. This provides a simple methodology for categorizing the likelihood of corrosion damage and its consequences by locating a given tendon in a particular bin on the risk matrix. Decisions regarding suitable actions are then based on the location on the risk matrix, with bins tending toward the upper right indicating higher risk and bins tending toward the lower left are lower risk.

**Figure 1 Illustration. Example risk matrix showing likelihood and consequence levels.**

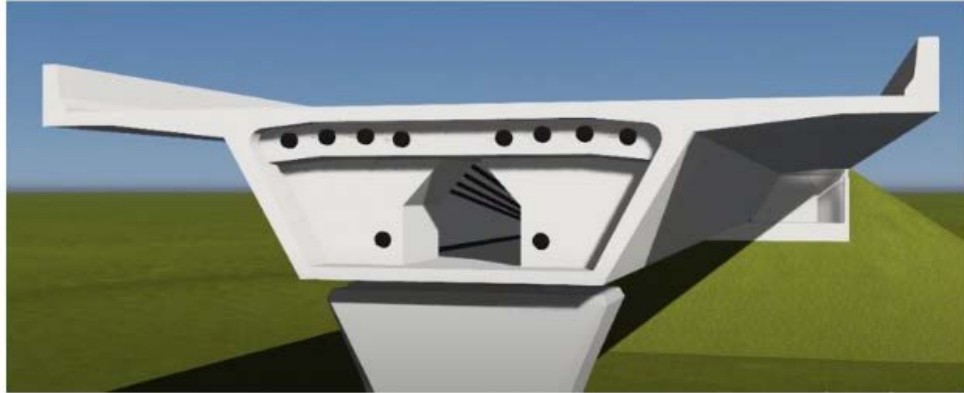
Example Bridge 2 is a single span, simply-support box girder with external PT. The structure is a 9-ft deep single-cell box girder with 5 external tendons per web, as shown in Figure A - 2. The tendon analyzed was a full-length tendon with a vertical profile of 6.6 ft, as shown in Table A - 4. The ambient environment surrounding the bridge is moderate. Tendon anchorages are located within the box girder and were treated as internal anchorages. The system level redundancy factor was found to be 1.1, with five

Figure A - 2. Illustrations Example Bridge 2 showing overall elevation (A), cross section at support (B), and internal views of external PT.

Based on the data for this bridge, the OF was calculated at 0.37 (115/325), which corresponds to a relative likelihood of corrosion damage as “Low.” For the CF,
