# JFK Causeway

Wiss, Janney, Elstner Associates, Inc.

Brian D. Merrill, PE

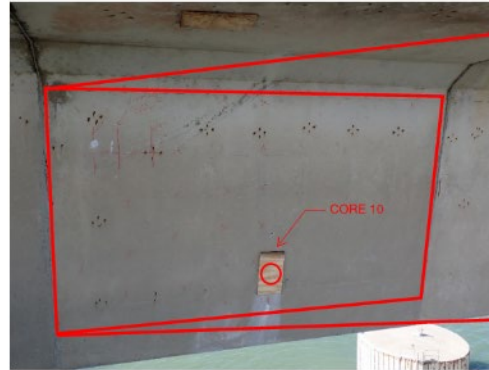
ASSESSMENT LOCATION OVERVIEW

- Design Clear Cover:  
1" top slab/wings  
1.5" for webs and  
bottom slab
- Black Rebar
- Std. Concrete mix
- No external coatings

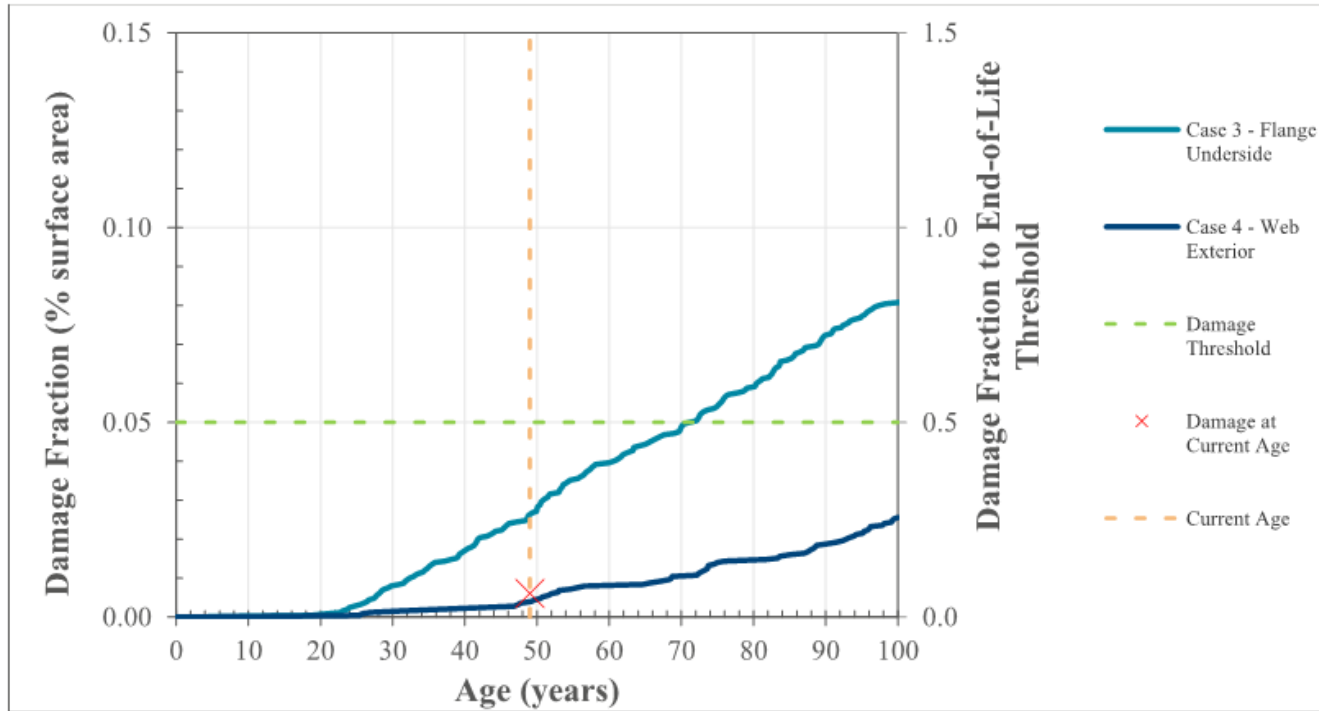
# Service Life Results

1. Deck surface in EB lanes:  
better overlay w/ membrane
  2. Deck surface for WB lanes:  
older overlay, no membrane
  3. Underside of wings
  4. Webs/bottom slab
- Clear cover to rebar matched plan dimensions
  - “extra” steel installed did not often match clear covers
  - Wind direction affected chloride exposure
  - ACP Overlay protects deck

- Replace overlays using membrane or use Polyester Polymer Concrete (PPC)
- Replace expansion joints
- Spot repairs to isolated spalling/cracking
- Water-repellant coating to exposed exterior surfaces
- Replace end tendon anchor pour-backs
- Possible cathodic protection system to piers
